Evaluation and repair of Algiers new airport building

This paper reports on the assessment study conducted by the authors on the new Algiers airport building. The evaluation approach included visual inspection of the concrete, seismic parallel method for piles testing and non-destructive testing of concrete with Schmidt hammer, ultrasonic pulse velocity measurements, cores testing, carbonation tests and also ambient vibrations of the structure. The diagnostic confirmed that the concrete was of low strength and showed many shortcomings such as inappropriate mix design with respect to coarse aggregate size of concrete resulting in honeycombing, construction errors such as lack of cover and the use of low slump concrete, poor placement and inadequate vibration. The repair work involved the application of ready mixed cement based polymer modified sprayed mortar with and without fibers on more than ten thousand square meters of honeycomb concrete, the injection of about five hundred linear meters of cracks and the repair of about one hundred square meters of corrosion damaged concrete at a cost of more than three millions US dollars.

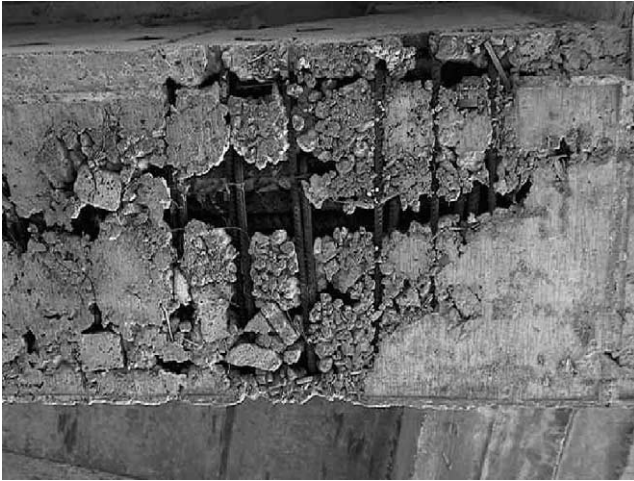
After an international bid, and for political reasons a local firm without any previous proven experience in this type of buildings was appointed to construct the building. A lot of deficiencies were observed during the construction stage. These deficiencies resulted mainly in segregation and honeycombing. Typical honeycombs are shown in Figs. 1 and 2 whereas Fig. 3 shows corrosion in a circular column due to water infiltration from a leaking expansion joint on the roof. Some thermal and shrinkage cracks were also observed on all

Fig. 1. Typical honeycombs in a reinforced concrete beam.

The first step of repairing of honeycombs and segregations was surface preparation by removing laitance and loose concrete by either pneumatically driven or hand-operated lightweight jack hammers and rust from the reinforcement bars by sand blasting and final cleaning by water jet. Simple geometrical prepared surface shapes were used to avoid differential drying shrinkage. Following the cleaning of the reinforcement, the bars were treated with a cement based coating containing a corrosion inhibiting admixture. Old–new concrete interface are often critical spots and optimum roughened old concrete surfaces is believed to be the most important step in a successful repair work and

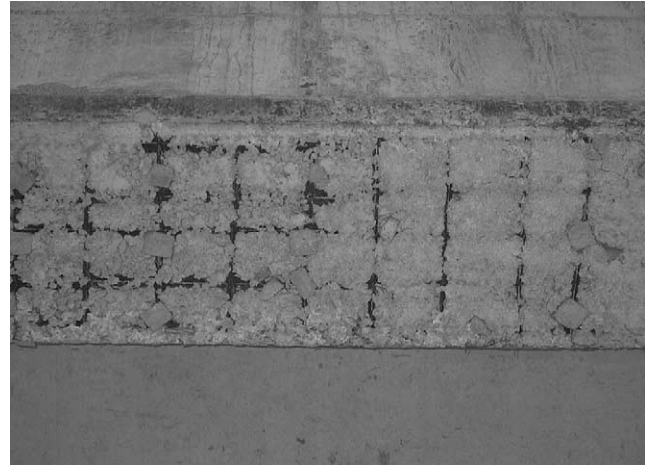
Fig. 4. Inadequate quality of concrete spacers.

25.7 long reinforced concrete beams with 2.0 m web depth. The quality of concrete spacers was inadequate (Fig. 4). The inspection of technical meetings reports, quality control of concrete strength files and records of tests on materials used confirmed that the concrete was of low strength. Many shortcomings were observed such as inappropriate mix design with respect to coarse aggregate size, construction errors such as lack of cover and the use of low slump concrete (80–100 mm) where plasticizer admixtures were rarely used, poor placement and inadequate compaction. The main cause of honeycomb concrete was severely congested reinforcing steel and inadequate spacing between parallel layers. Fig. 5 shows reinforcement congestion in a beam.

Although the number of spacers used was very large, these were site made and of low quality. BS 8110 [7] prohibits the use of site made spacers and the concrete society recommends that concrete spacers be made of a minimum of grade C50 concrete [8]. These spacers are likely to be critical as they affect the quality of the concrete cover. Absorption tests were conducted on some of these spacers. The units were first dried to a constant weight (W_d) and then immersed in water at 20 °C until a constant weight (W_s). The water absorption (W_a) is given by:

The results of tests on six spacers of varying dimensions from different locations gave a water absorption of 10–13% indicating a higher porosity and a higher open pores volume and hence a lower durability. It was proposed to take out all apparent spacers and apply a repair mortar on the beam bases to enhance concrete appearance and durability.

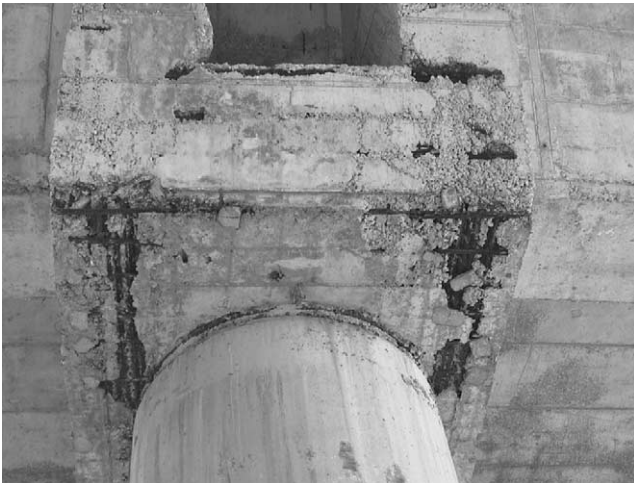
Fig. 2. Typical honeycomb at a column-beam junction.

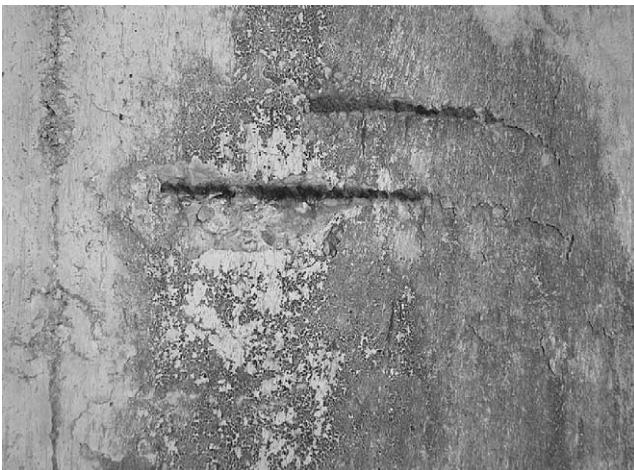
Fig. 3. Steel corrosion at the head of circular column.

[6] for low strength concrete (20 MPa) who found k varying from 6.0 to 8.1 mm/year^{1/2}. Inadequate compaction and improper curing seems to be the cause of the carbonation and carbonation induced corrosion problems which started to occur in this relatively short time (5–10 years).

As shrinkage deformation is believed to be significantly affected by the curing environment especially under hot climate [13], curing was started immediately by sprinkling water for a minimum of three days. No shrinkage cracks were observed. In the case where shallow concrete cover was encountered with no apparent segregation or honeycombs and in order to reduce the undesirable noise and dust of concrete removal, a corrosion inhibitor was applied by a roller on the entire surface. The material is based on an organic and inorganic, film forming, blended amino compound that allows the inhibitor to diffuse through the concrete and form an adsorbed layer on the surface of reinforcement that displaces any hydroxides on the steel surface. A further coating was applied to concrete which will not be clad or rendered at a later stage to keep carbon dioxide from permeating into concrete and gives a better appearance.

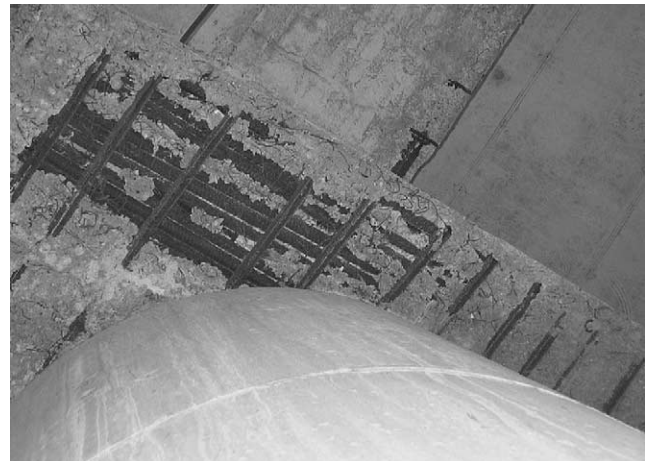
Fig. 5. Reinforcement congestion in a beam.

The concrete mix was not designed so that the largest aggregate size can pass between adjacent bars and between form and the reinforcement. ACI 318 [1] requires that the nominal maximum size of coarse aggregate shall

not be larger than $3/4$ the minimum clear spacing between individual reinforcing bars and that clear distance between parallel bars in a layer shall be not less than the nominal diameter of the bar or 25 mm.

only 20 or 25 mm bar diameters were available on site and hence smaller bar spacing was provided as shown in Fig. 5 where some bars are in contact. The concrete mix design contained a 30 mm maximum aggregate size and a slump of 70–100 mm and hence concrete placement was difficult resulting in honeycombing. Honeycombing was also observed in the vicinity of wall penetrations. The honeycombs could have been avoided using appropriate mix design with lower aggregate size, appropriate workability and thorough consolidation.

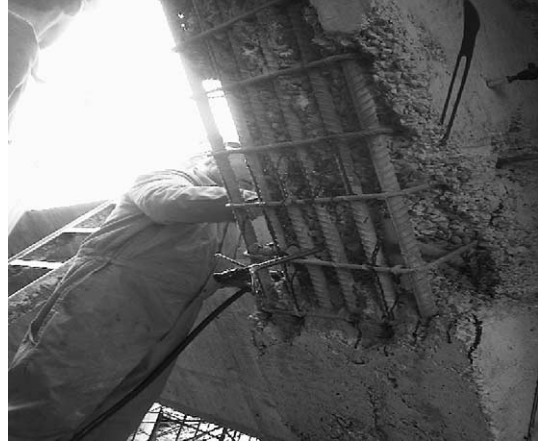
The drawings showed steel diameters not available locally and hence smaller diameters were used without amending reinforcement details resulting in a further decrease of bar spacing. In addition to that, workability was low and did not permit the concrete to be worked around reinforcement causing segregation particularly in shear walls and in the bottom of the sloped parts of the beams which seem not to be well vibrated by external form vibrators as clusters of coarse aggregates with little mortar were found (Figs. 6–8).

Fig. 8. Clusters of coarse aggregates in a sloped part of a beam.

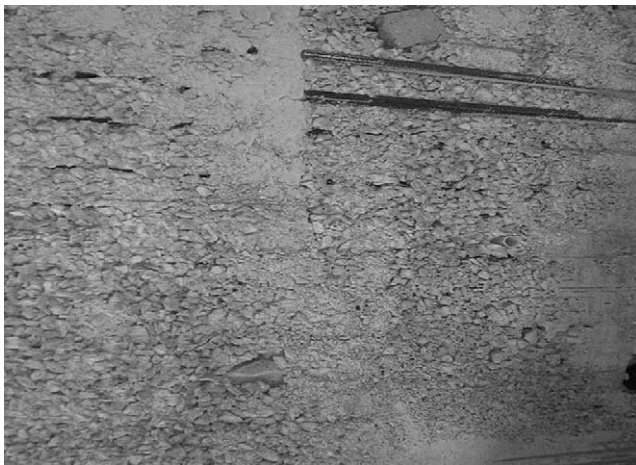
Fig. 6. Clusters of coarse aggregates in a shear wall.

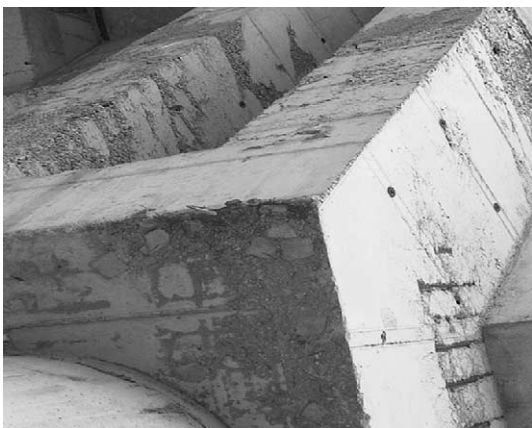
Fig. 7. Clusters of coarse aggregates in a sloped part of a beam.

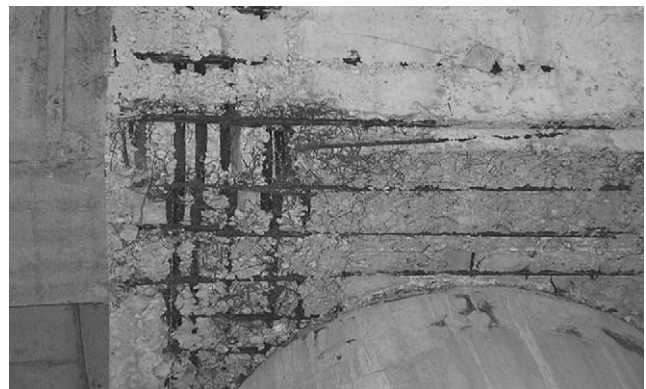
It can be seen that forms were not well cleaned prior to concrete casting as steel tying wires and dust was seen on the bottom of beams (Figs. 9 and 10). Frequent changes in the source of constituent materials (mainly sand and gravel) were also noted.

Fig. 9. Steel tying wires at the base of a beam due to non-cleaned forms.

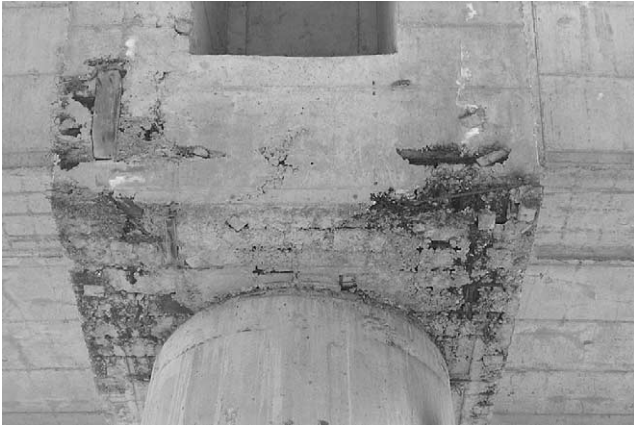
Fig. 10. Steel tying wires at the base of a beam due to non-cleaned forms.

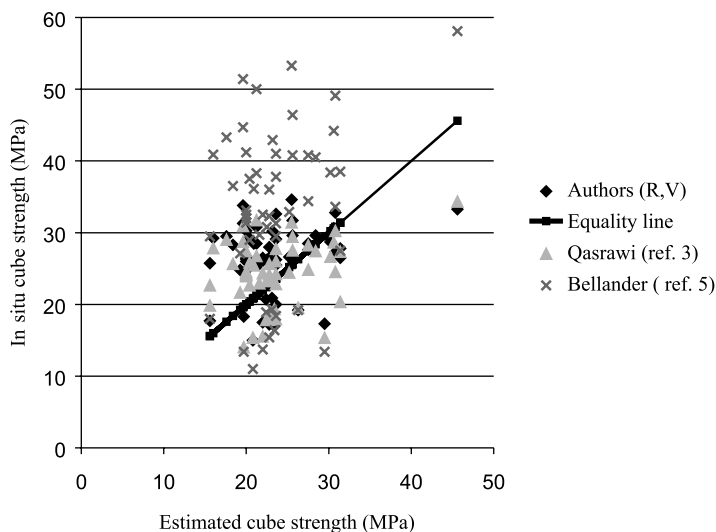
Fig. 11 showed the estimated concrete strength by this method is better than that proposed by other researchers [2,5].

Fig. 11. Predicted in situ concrete strength using various methods.

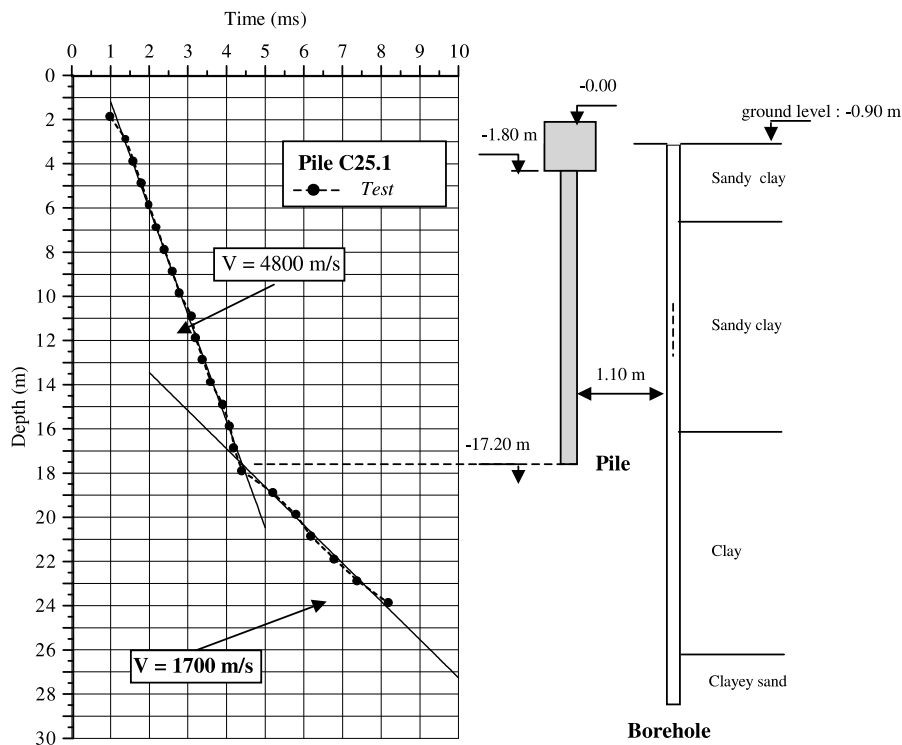
varies from 14 to 28 m giving a total length of 31 492 linear meters. For access and cost difficulties, only eleven outer piles were tested by the parallel seismic method. Six bores of 24 m depth and five of 33 m depth were drilled, tubed and filled with water. The method consists of boring a 40–60 mm bore holes parallel to the pile to be tested at a distance not exceeding 0.5–1.5 m and to a depth slightly higher than the depth of the pile. The method is based on the measurement of the speed of waves through concrete and soil. A hammer is struck on top of the pile and time, for the impulse wave to reach a receiver which is moved progressively at a step of 0.5 or 1.0 m inside the hole, is monitored. Hence, the depth of the pile is measured and pulse velocity in both the concrete and the adjacent soil is found. Fig. 12 shows a typical depth–time curve for a tested pile. All piles tested were found to be cast to a depth exceeding the theoretical depth by 0.7–1.0 m. The ultrasonic pulse velocity in concrete varied from 4200 to 4800 m/s and hence the quality of concrete could be classified as good to excellent [9]. No defect or voids were observed in the tested pile.

Fig. 12. Typical depth–time curve for a reinforced concrete tested pile.

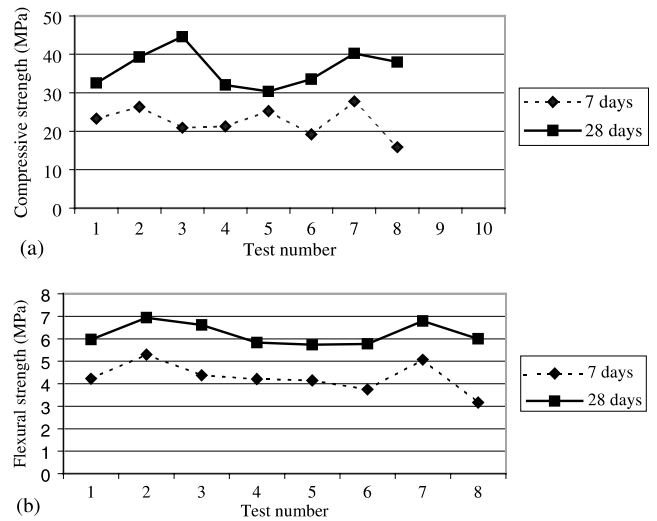
The high cost incurred in repairing the structure makes it essential to conduct a thorough quality control program on materials and workmanship. Poor on-site practices and indifferences to quality control during the repair installation, often produce a final product of dubious quality [14]. The compressive and flexural strength results of repair mortars are presented in Fig. 13 showing high variability of in situ repair mortars compressive strength from different batches though the strength was up to standards.

Fig. 13. In situ compressive and flexural strengths of the repair mortar used: (a) compressive strength; (b) flexural strength.
